## Analytical Sciences

### RE: **Sample Report – Analysis on Discoloration of In-Mold Waterborne**

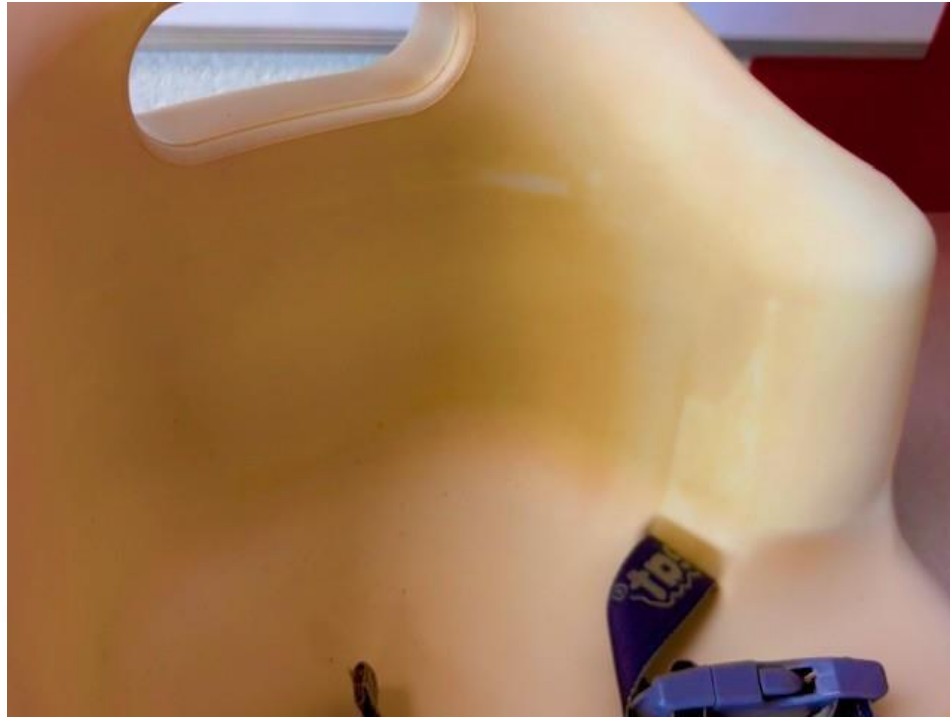
**Figure 1 – Photograph of Submitted Part**

One car seat coated with in-mold waterborne coating was submitted to Red Spot Analytical Sciences to determine the root cause of the car seat turning orange. The customer was concerned that the use of cleaning wipes the parts was turning them orange. Inspection of the part showed the interior areas of the car seat were more strongly discolored than areas along the bottom and the outside rim as seen in Figure 1. Areas with the expected white appearance were wiped with different cleaners in an attempt to replicate the issue but were not observed to have any significant changes.

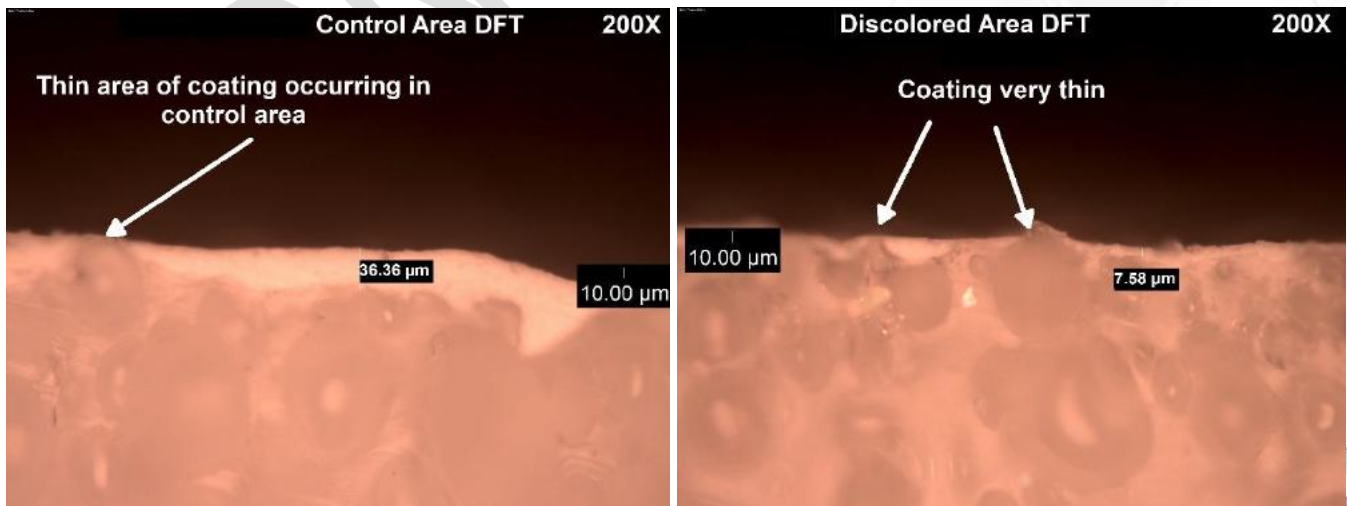
**Figure 2 – Cross-sections of 558W52 on Car Seat**

Film builds on the car seat were measured using ISO 2808 method 6A version 2. The film builds of the discolored area were determined to be much lower at 7.58 microns than compared to the control area film build of 36.36 microns. Cross sections on these areas in Figure 2 showed variance in the coverage over the substrate regardless of the overall appearance. Control areas were found to have spots with little coverage over the substrate but not to the same extent as the discolored areas.

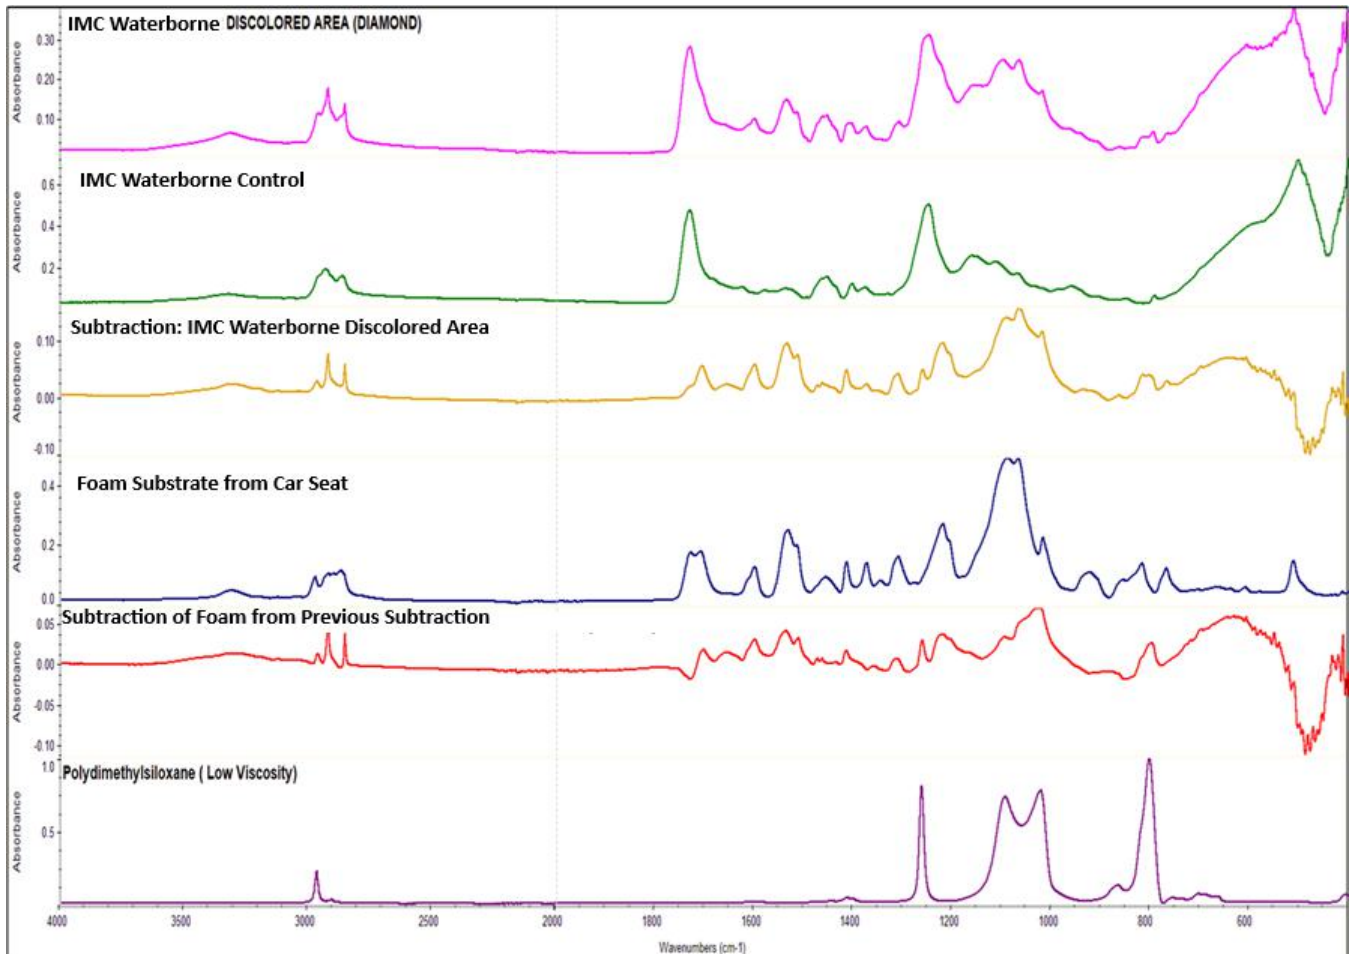
## Figure 3 – FTIR Spectra of IMC on Car Seat Against Knowns

FTIR spectroscopy was performed on the discolored areas of the car seat and compared against the control. Analysis of the discolored areas of coating detected materials that matched the substrate as well as other unknowns. Subtractions were made between the collected spectra and identified the remaining peaks present to silicone. The FTIR spectrum of the waterborne did not have a silicone peak and was believed to be sourced to the mold release for the parts.

Initial FTIR analysis showed extra peaks present that were not explained by the coating itself. The subtraction in line 3 indicated that some of the peaks corresponded to the polyurethane foam substrate. Further subtractions were able to detect silicone, a known mold release additive. Comparisons were made between the discolored areas and areas with good appearance and found little evidence of the polyurethane substrate or silicone present in the good areas.

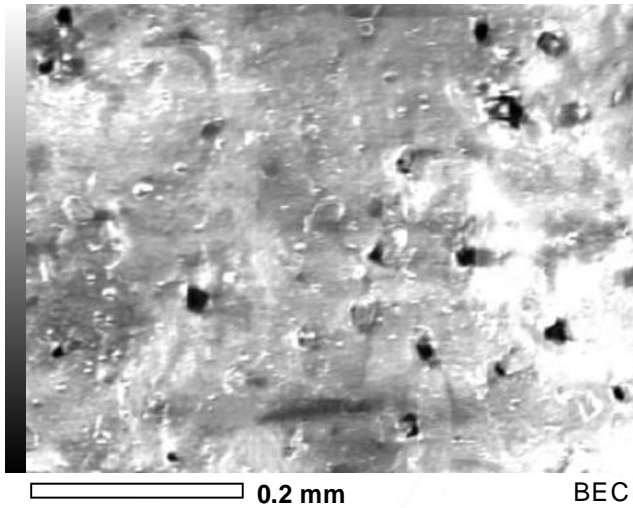
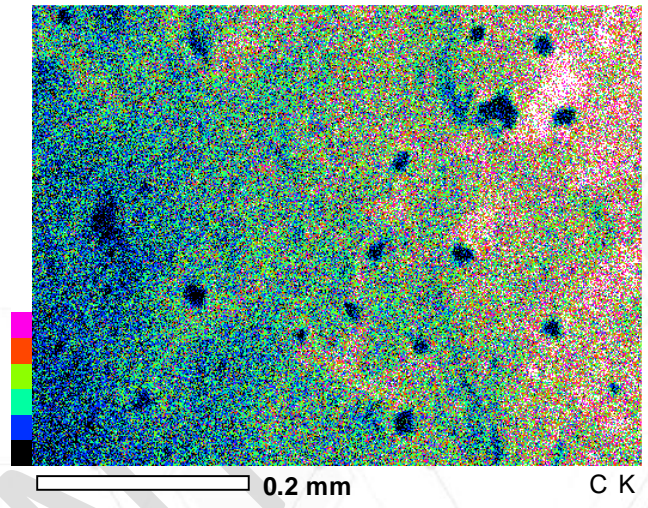
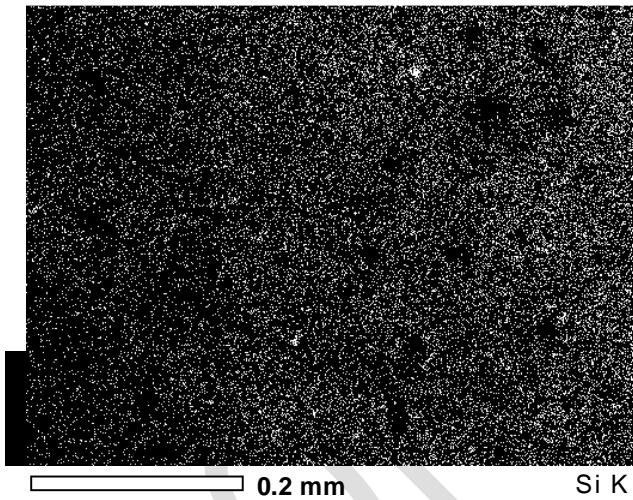
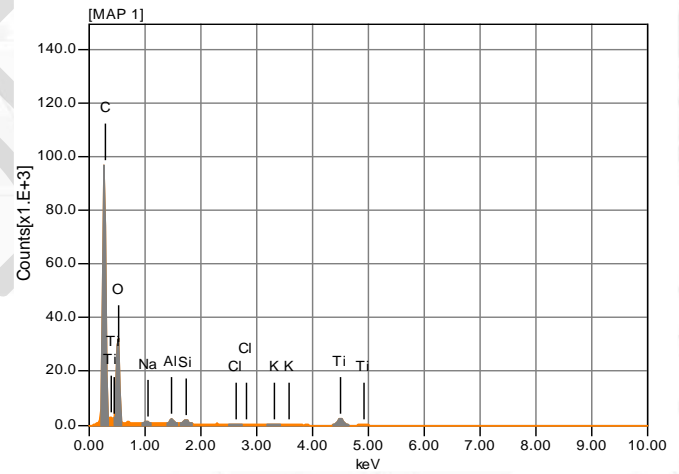
**Figure 4 – SEM-EDX Spectra of IMC in Discolored Area**

SEM-EDX spectral analysis was used to determine whether the silicone was localized to only the exposed substrate. Scans on the discolored area demonstrated a high concentration of several elements in discrete locations, indicating that the coating was not uniform across the part. Elemental silicon from the mold release was found in all areas of the part but in higher concentrations in areas with the orange appearance. Silicone is not known for reacting with polyurethane foam and was not believed to be directly responsible for the discoloration. Its presence primarily in discolored areas meant it was likely connected to the thickness of the waterborne coating.

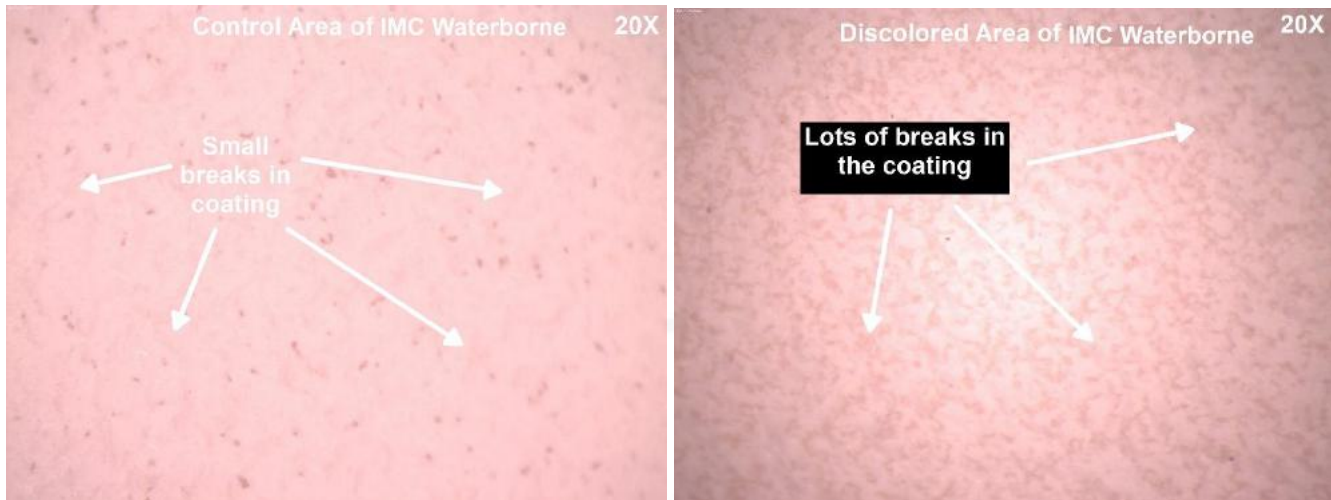
**Figure 5 – Photomicrographs of Inconsistent Coverage with IMC**

Inspection under optical microscopy was conducted to isolate the relationship between the coating and the appearance. A knife was used to scrape the coating off the substrate and look for the effects of discoloration in both the coating and the substrate. The test was to determine if the discoloration was connected to a failure in the coating or a reaction in the substrate. Removal of the coating from the foam increased the amount of orange discoloration observed. This indicated that the discoloration occurred in all areas of the seat but could only be observed in areas without the coating over the substrate. Further

Slices were made on different sections of the substrate and showed that the foam was discolored directly beneath the coating region. Sections of the uncoated substrate were soaked in different common cleaning solvents to test if the discoloration could be recreated at deeper layers. Soaking with the solvents were shown to affect the structure of the substrate and cause discoloration. It was believed that the low film builds and inconsistent coverage of the part in areas allowed for the migration of these solvents to discolor. Areas with higher concentrations of silicone due to mold release corresponded to these low film build areas and was determined to be responsible for the poor coverage over the substrate.
